Testing the Energy Performance of Wood Windows in Cold Climates

A Report to
The State of Vermont Division for Historic Preservation
Agency of Commerce and Community Development

August 30, 1996

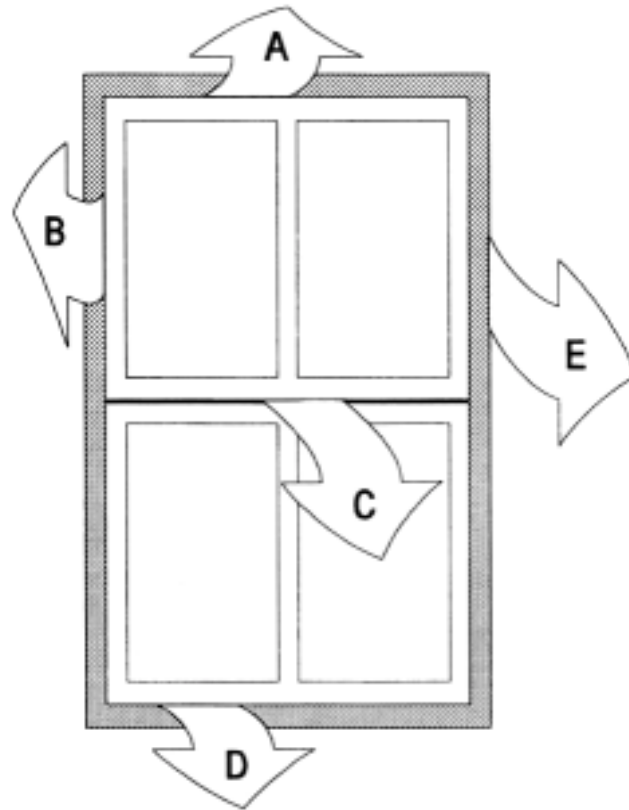
Figure 1: Principle air leakage sites for a typical double-hung window

- A - air infiltration through the head junction
- B - air infiltration through the sash/jamb junction
- C - air infiltration through the meeting rail
- D - air infiltration through the sill junction
- E - air infiltration through and around the jamb from the rough opening

losses were investigated by field and laboratory pressurization testing. Figure 1 is a schematic diagram of a standard double-hung window, showing typical air leakage sites for that style window. Non-infiltrative losses include conduction, convection, and radiation through the materials of the window and were simulated using a computer model.

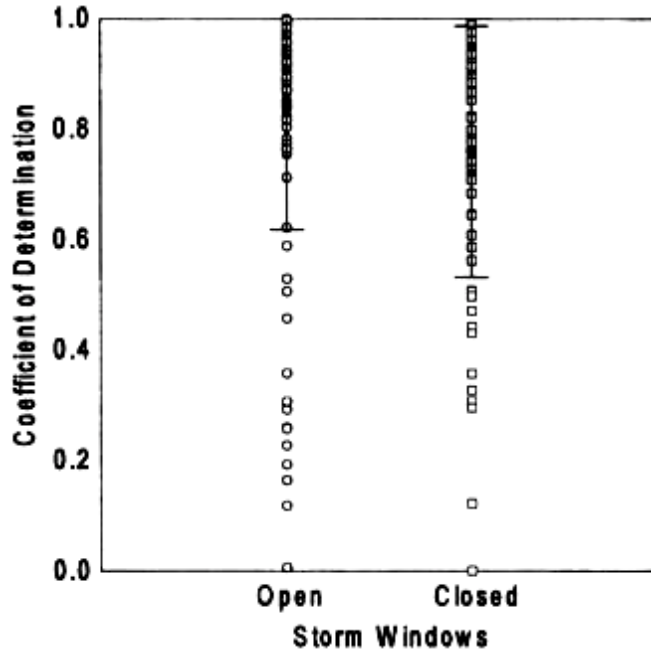
Figure 2: Variability in R^2 values of standard flow model fitted to the field data

A larger variation in R^2 values was observed for those windows allowing little induced air

leakage. For those windows, the effect of even moderate winds on test accuracy increased as both air flow rates and pressure differentials decreased. Table 3 shows wind speeds equivalent to pressure differentials used in the test, with pressures being expressed in both conventional (Inch-Pound) and metric (SI) formats.

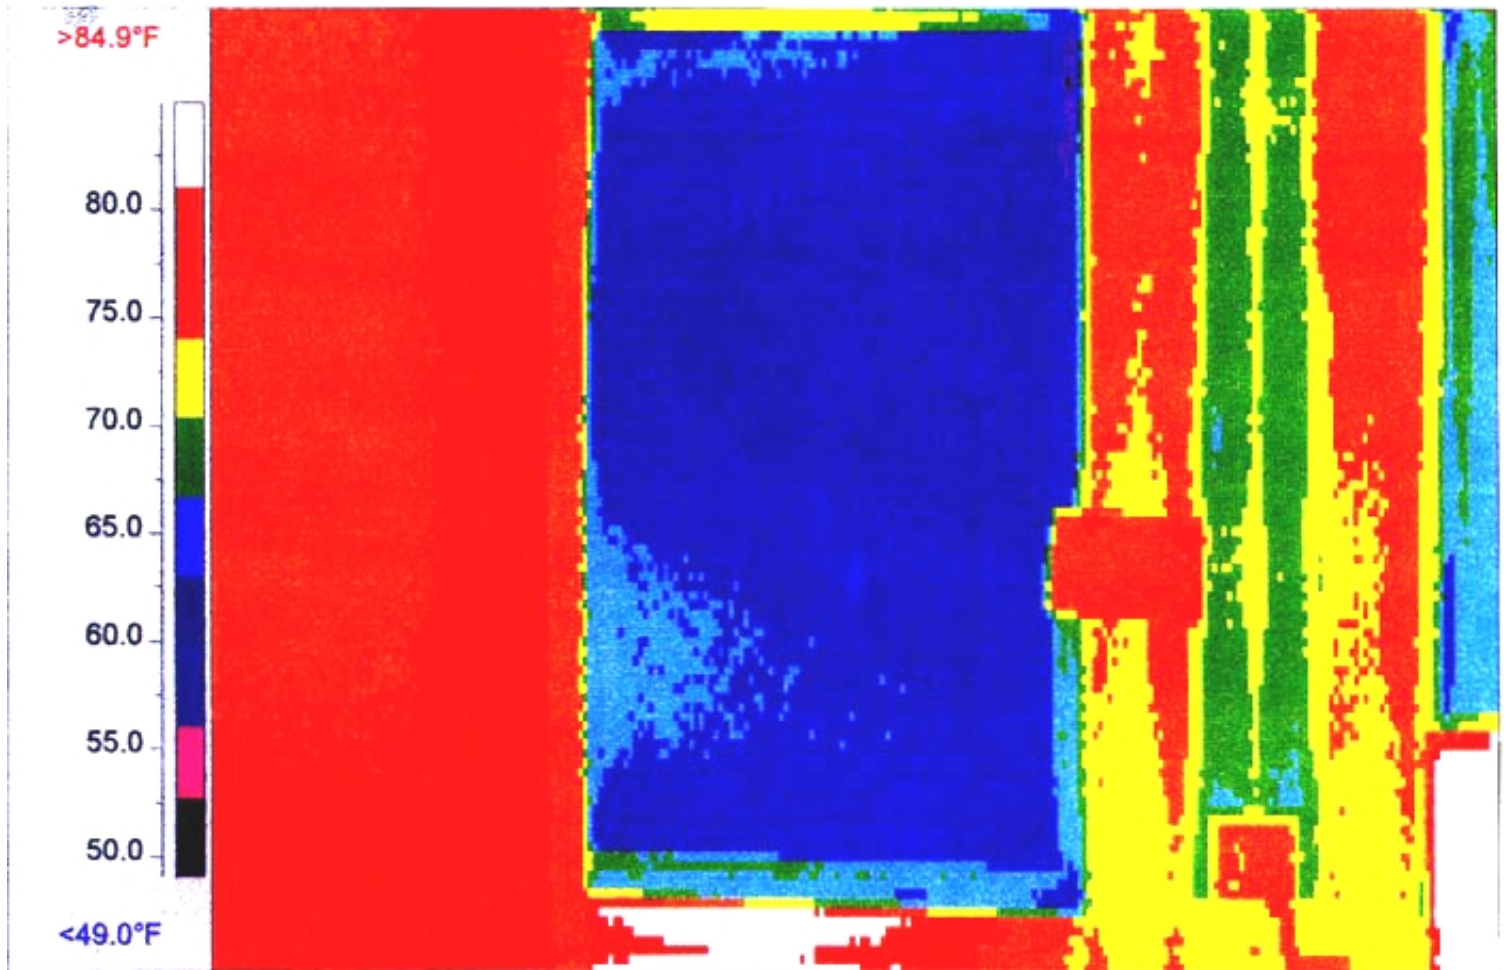
Figure 11: Thermograph of Robinson Hall window with no effective storm attached

Any conclusions based on the Robinson Hall thermographs must consider the effect of unequal space heating. As in most old buildings, hot water radiators were situated beneath the windows. The temperature regimes of the radiators varied considerably from window to window with the coolest radiator being below the coolest window and the hottest radiator being directly beneath the Bi-Glass System upgrade. The radiators likely had a significant effect on the glass surface temperatures, but it is unlikely either of the other two windows would have achieved as high a center of glass temperature as the Bi-Glass window.
